NOTES ON FBG POST-ACCIDENT REPAIR & RECOVERY

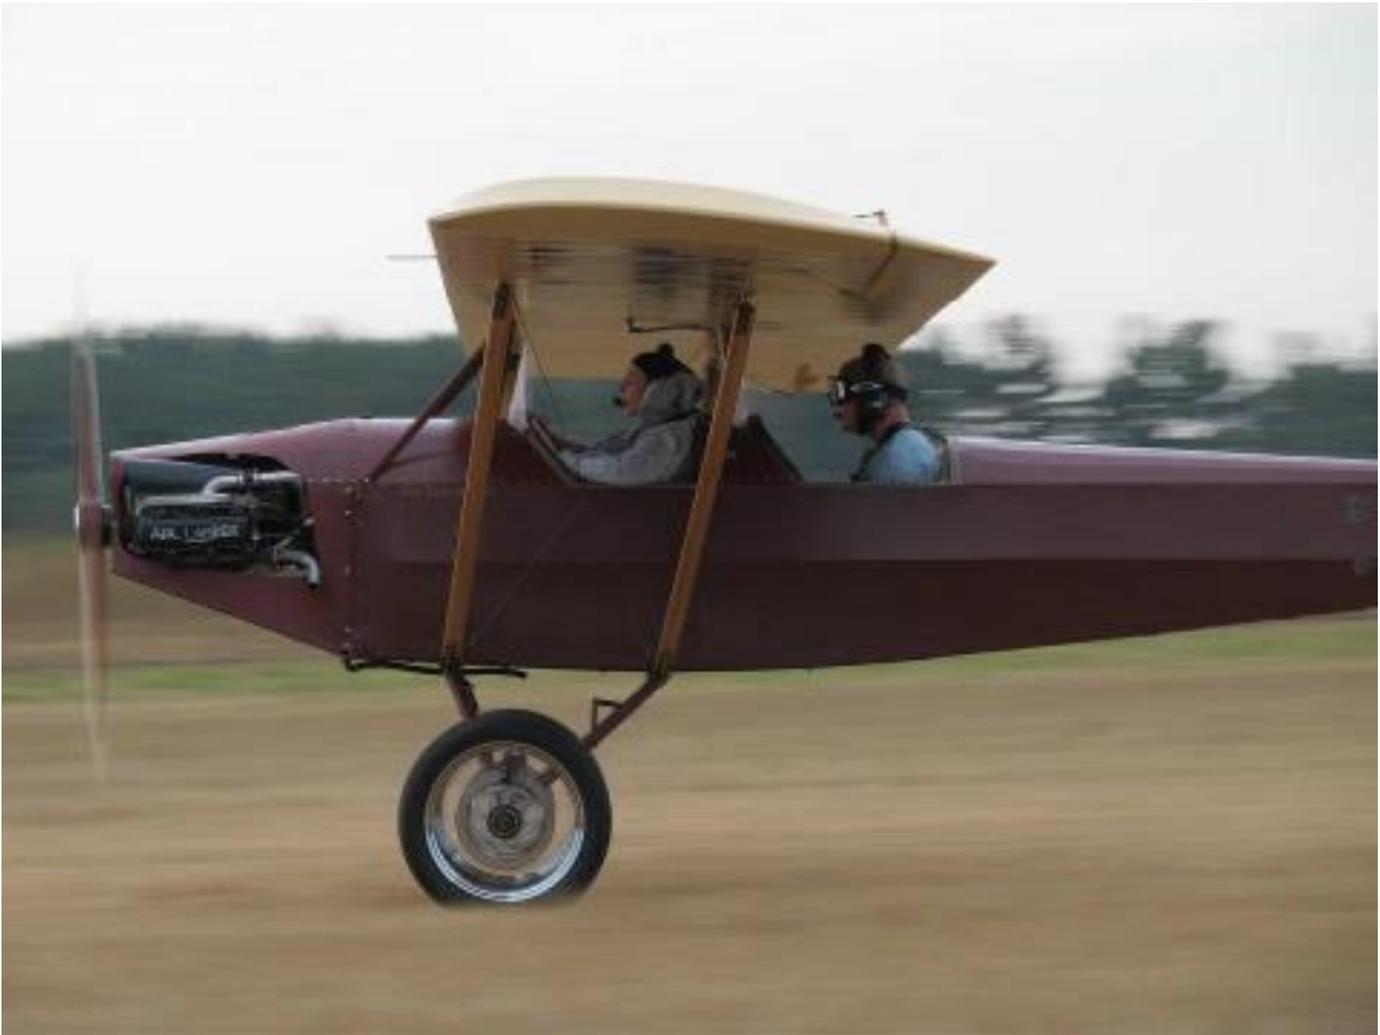
The shoulder harness passed through a slot in the top of the turtle deck former. This was as high as I could place the harness without adding some type of headrest. You can see in the photo that the harness rode a couple of inches lower than recommended by my Tony Bingelis.

The harness broke the plywood it passed through, though it essentially stayed in place. My two top ribs were broken, though not badly, and my collar bones were not damaged. The harness was attached to the upper longerons about 18" behind the seat back with simple two-bolt fittings and a double strand of 1/8" cable. The right hand attach point was damaged by the crash. The left side attach point was intact. We typically think of the performance of restraint systems in the context of a head-on crash. I think mine would have done ok, though raising the shoulder harness a couple of inches would be wise.

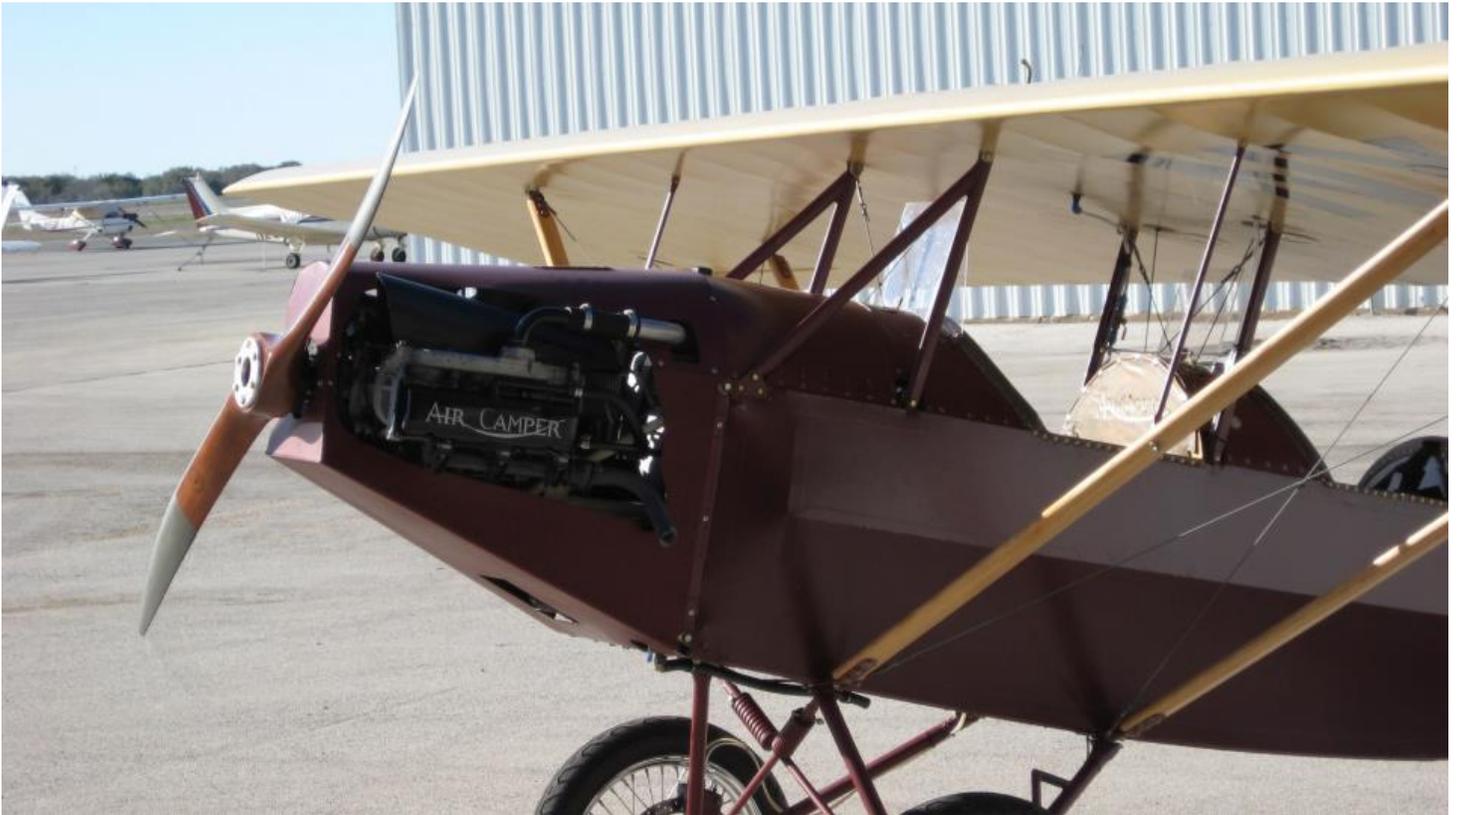
I originally used the cross-wires but took good advice and welded on diagonal cabanes. I've only seen one of the diagonals, and truly have no idea where the other one is, but the one I have performed beautifully. The strut is bent but the weld at the top and the bolted attach point at the bottom worked as designed.

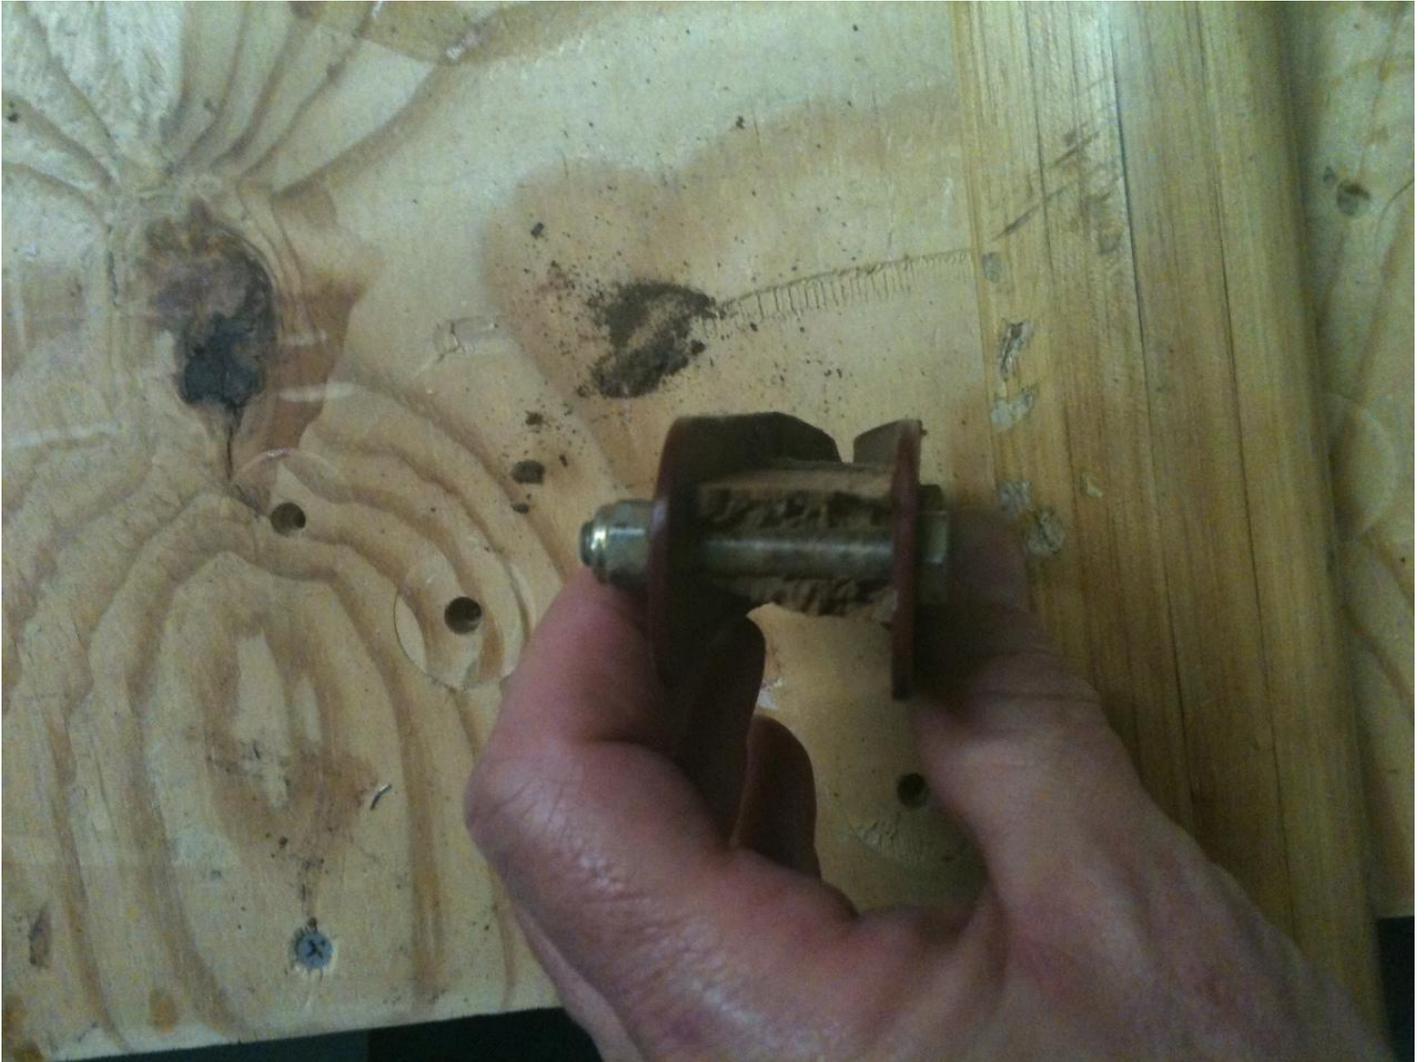
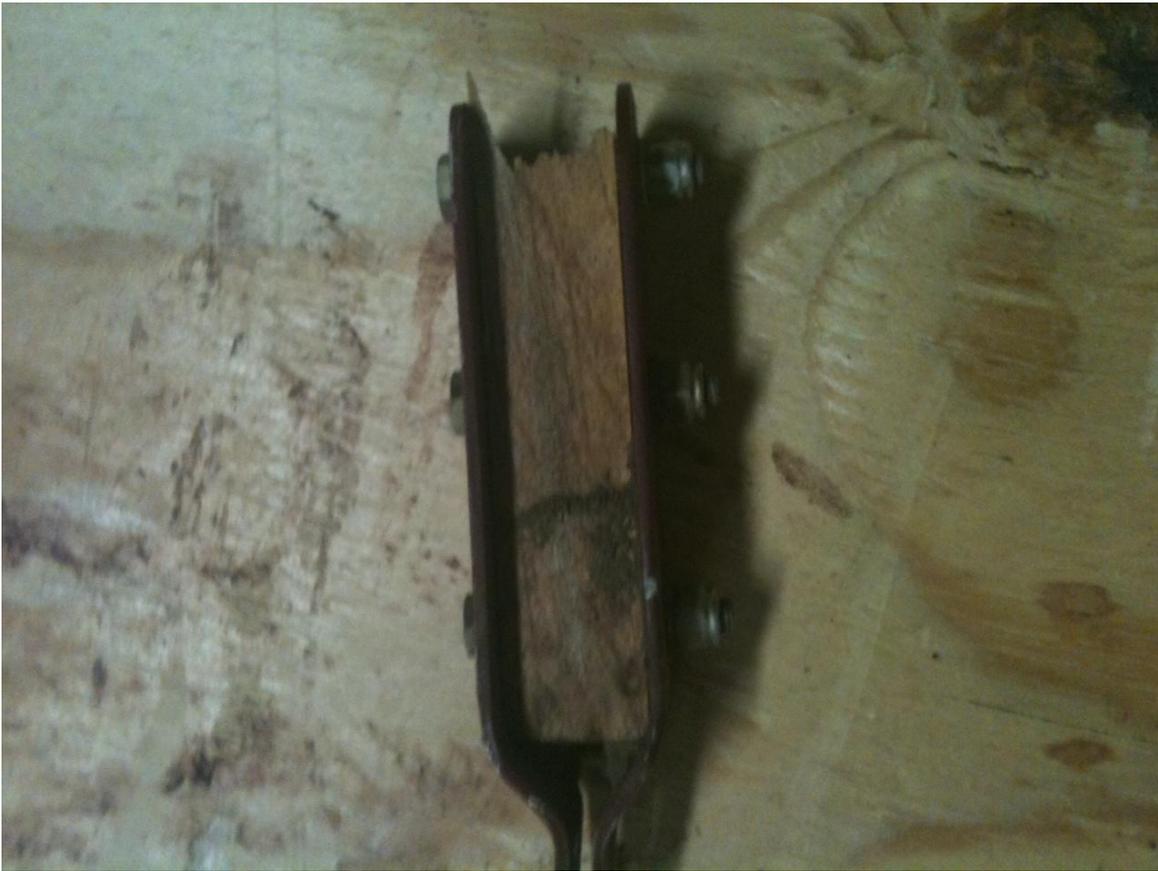
Here are a few pictures of the right front bottom attach fitting. You'll notice that the strut is gone except where it's bolted to the fitting. This fitting took the greatest impact.

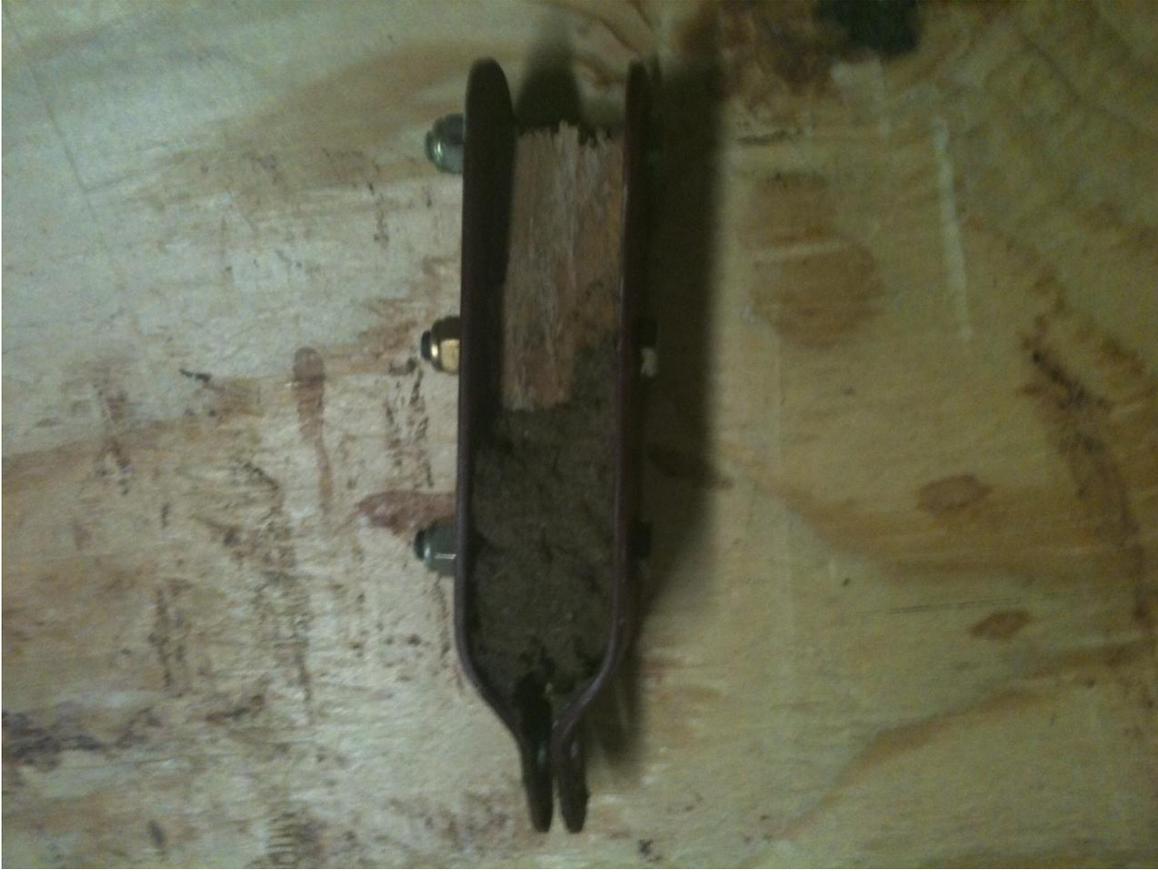
I get a kick out of the cornfield dirt in this picture.

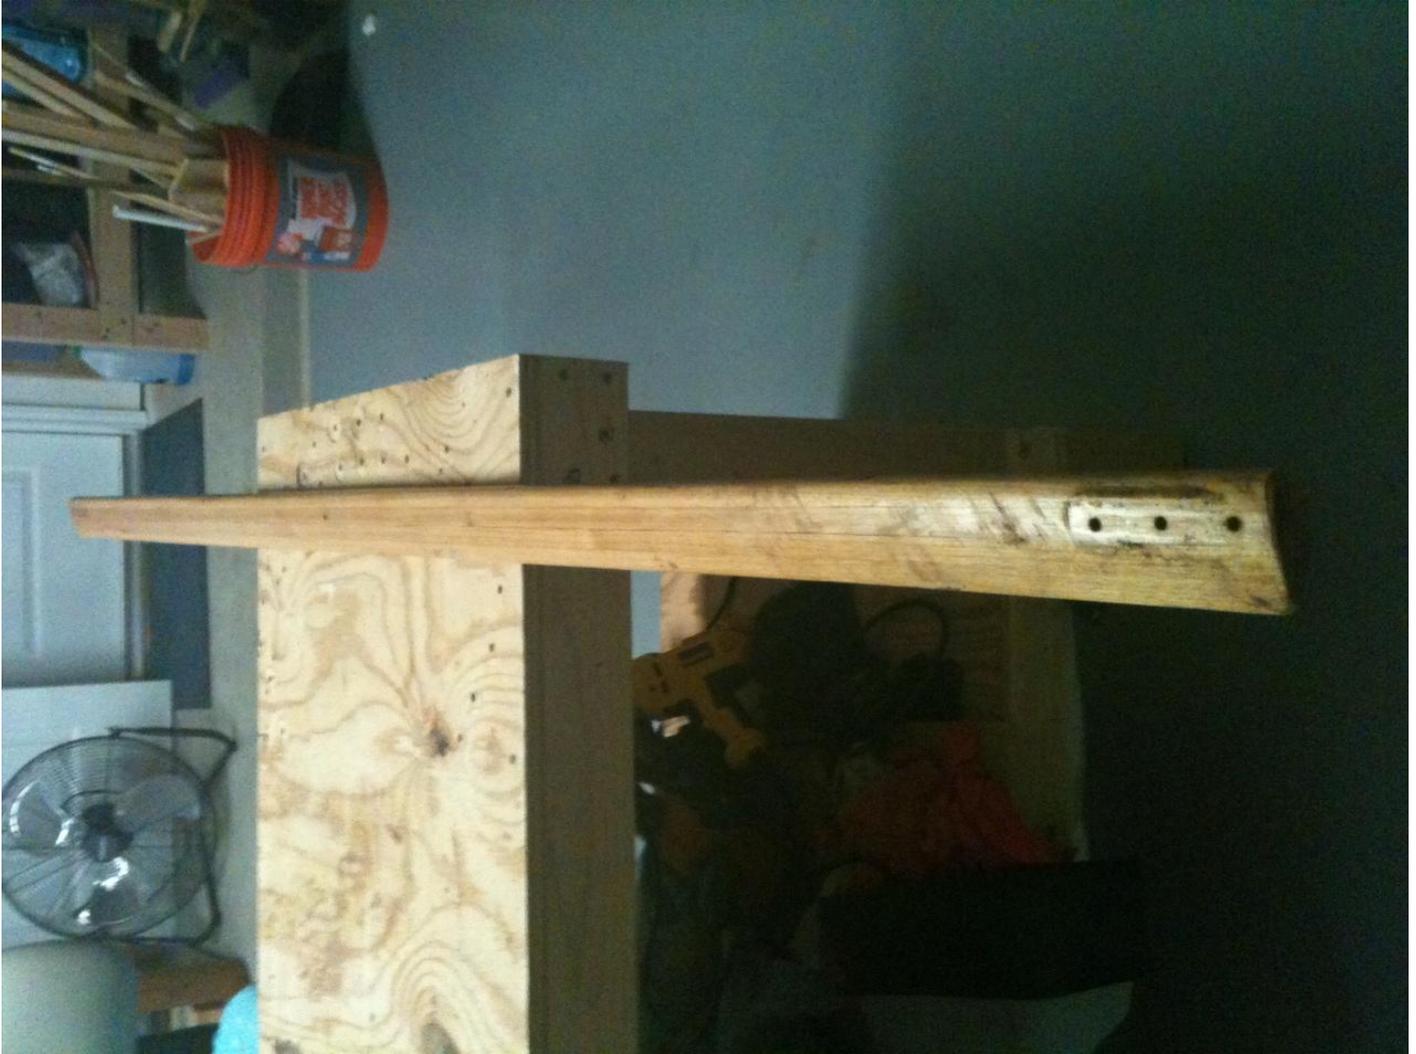
Here's a picture of the damaged left strut. You can see some deformation about a foot from the near end. Note, however, that the bolt holes are in great shape.

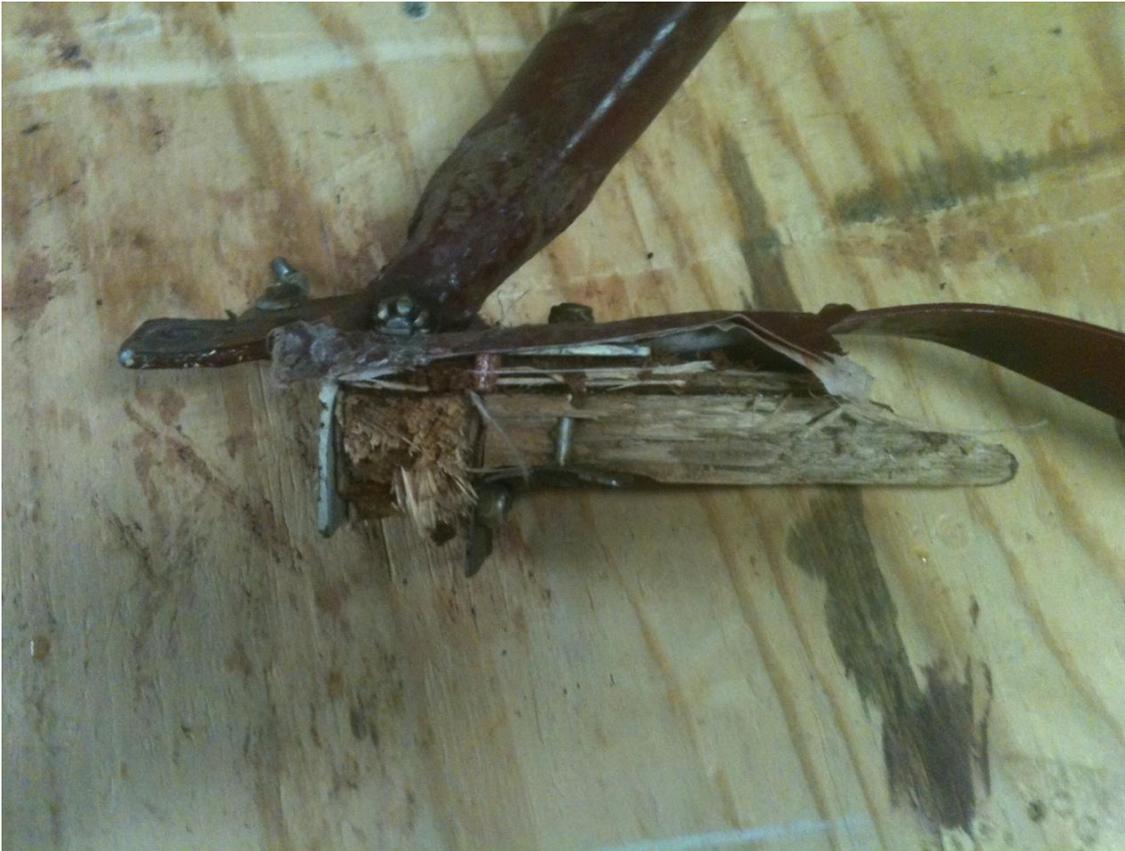
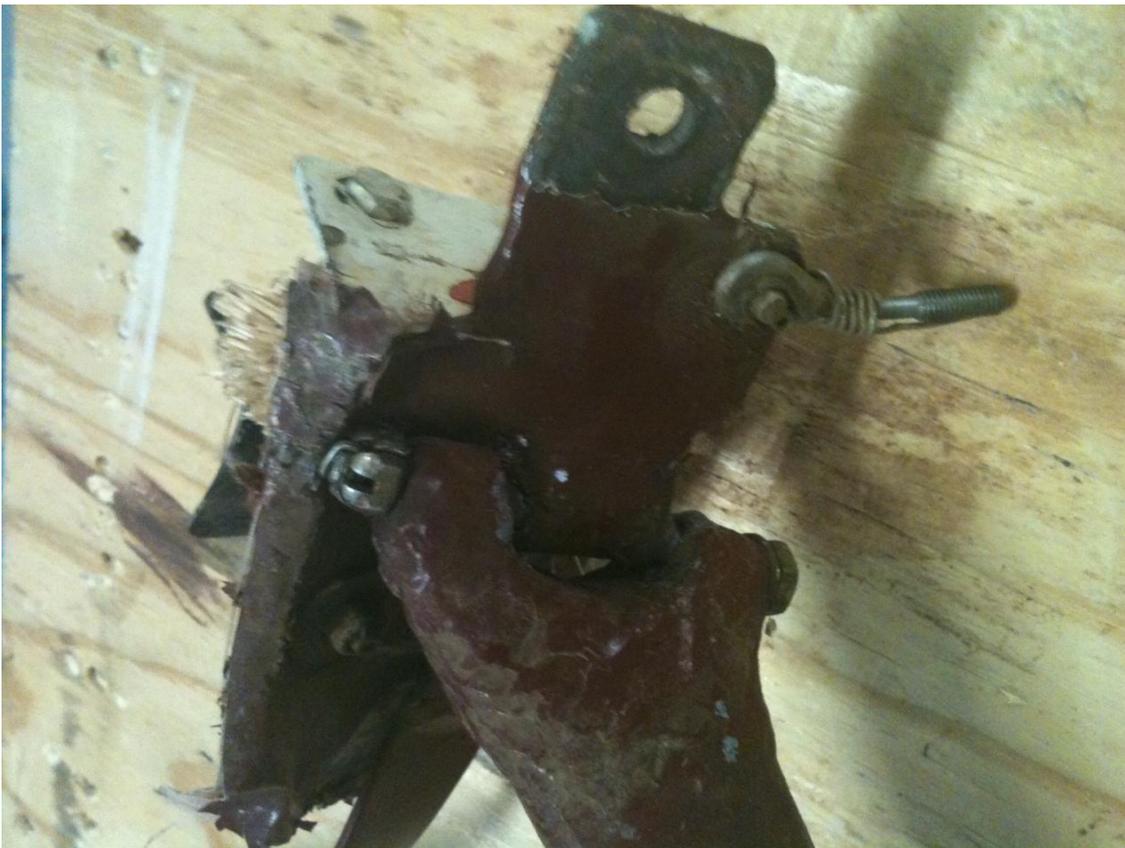
I include these pictures of the right rear landing gear/wing strut attach point as a testament to the durability of the design. It's a good example of how the aircraft fails so you don't have to.
